# Manhole Inspection Summary

Manhole # S39GG1006MH

Insp Date: **1/17/07 10:38 AM**

**Location** Address: **814 ARGONNE DR**

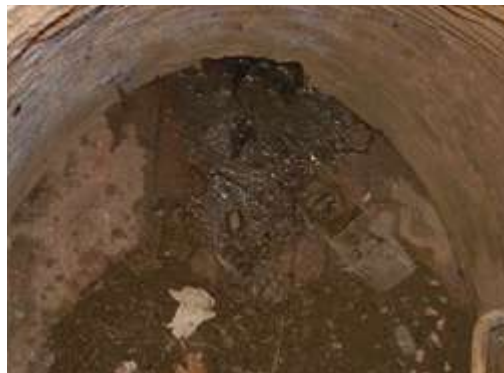
Top View

**Channel** Material: **Brick** ☐ Parged ☒ **Debris** (not Condition related)

Channel debris.

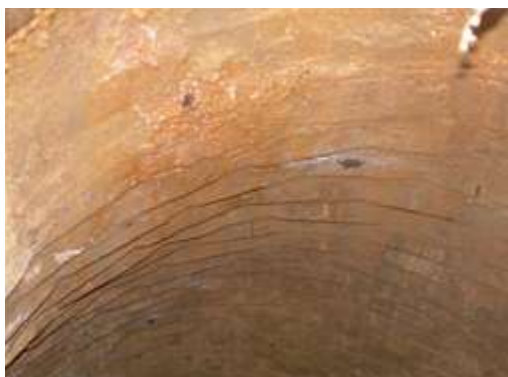
Defect

**Chimney / Frame Adjustment** ☒ Exists Material: **Brick** ☐ Parged Height: **18** (in.)

Infiltration: ☐ None ☒ **Joint** ☐ Cracks ☐ Mortar ☐ Roots ☒ **Wall**

Adjustment infiltration.

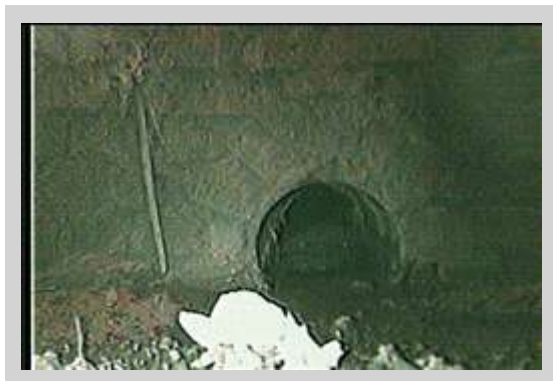
8 in. Circular Gravity Sewer

Condition: ☐ Sound ☐ Cracked ☒ **Root Intrusion** ☐ Loose Brick ☐ Deteriorated

Infiltration: ☐ None ☐ Joint ☐ Cracks ☐ Mortar ☒ **Roots** ☒ **Wall**

Barrel root intrusion and infiltration.
